Design Guidelines

DOWNTOWN HISTORIC DISTRICT

HISTORIC PRESERVATION
URBAN DESIGN DIVISION
DEPARTMENT OF PLANNING
RESEARCH AND DEVELOPMENT
CITY OF EL PASO, TEXAS

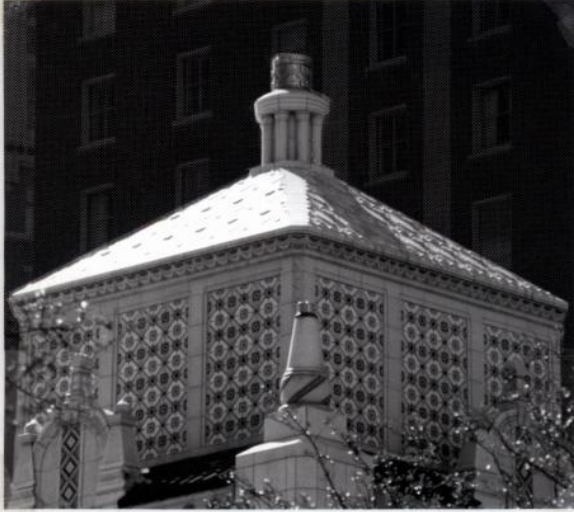
The Kress Building was designed by Edward Sibbert in 1937. It has three street elevations: Mesa, Mills and Oregon. It also has an eighty foot tower on the corner that faces San Jacinto Plaza. The Kress Building is a dramatic display of terra-cotta in oyster white with red, blue, green and gold ornamentation. Design is generally Moorish with Spanish touches in the wrought iron balconies. The Kress Building was added to the El Paso Historic Sites Inventory in 1978.

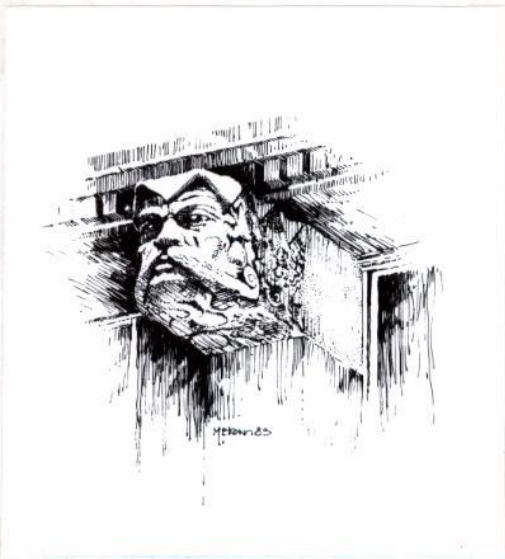
Bassett Tower was once the tallest building in El Paso, rising 15 stories. There is a basement and mechanical rooms are located in the tower. Ornamentation is limited to the ground and uppermost level. The building's entrance is an elaborate display of Art Deco design elements and is the focal point of the southeast facade of the ground floor. Included in the composition are facial expressions, one of which is believed to be a likeness of Henry Trost. Terra-cotta, art stone, marble and granite ornamentation are found on the first uppermost floors. Ten eagle sentries guard the 15th floor and the tower is topped with a steep copper hip roof.

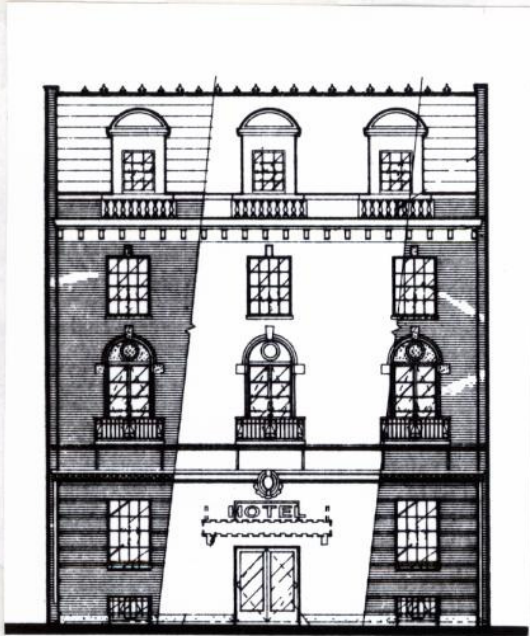
The Plaza Hotel is composed of a two story "trapezoidal" base supporting a rectangular fifteen story tower. Construction is of red brick and vertical and horizontal concrete bands create contrast. Ornamentation extending around the entire building is limited to the first two floors consisting of simple pilaster, geometric Art Deco spandrels and multicolored roundels. The finishing touch is the green terra-cotta tile roof on the tower.

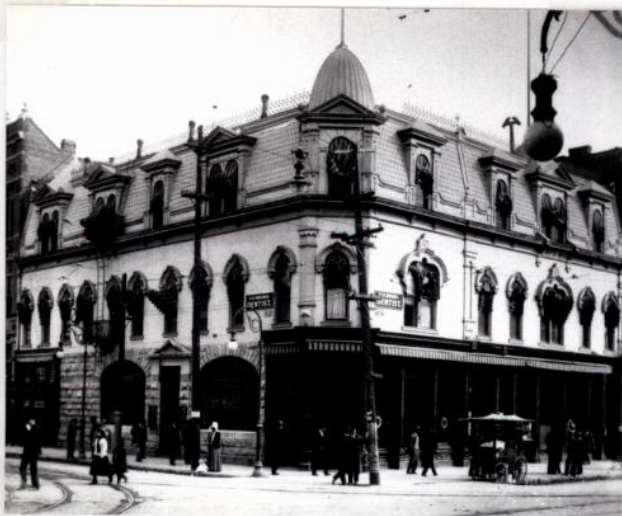
First National Bank (Star Jewelry)

The First National Bank building was constructed in 1882-83 for Joshua Reynolds, then president of the First National Bank in Las Vegas, New Mexico. The upper floors of the structure were originally leased for professional offices. The first National vacated the property when it merged with the American National Bank in 1914. Since that time, the property has exchanged hands at least six times, and today it houses Star Jewelry.

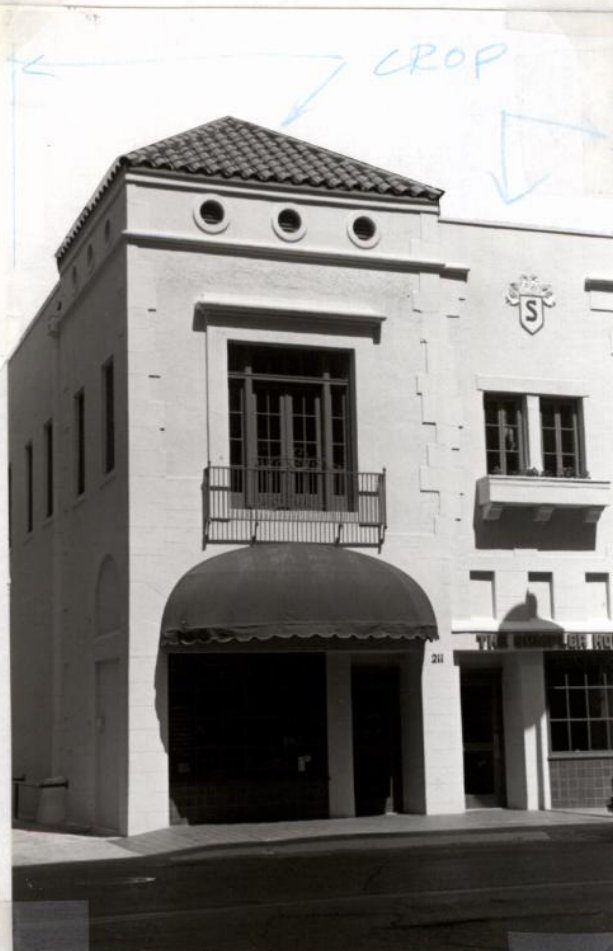
The Singer Building is a two story, rectangular structure. The building is constructed of poured concrete with a plaster finish, and it shares a common wall with the J.J. Newberry department store. The storefront is divided into two bays of different sizes, one of which takes on a tower like appearance and is topped with a red-tiled, pyramidal roof. A broad arched opening, balconies, grillwork and concrete quoins further carry the Mediterranean theme. The Singer crest is implanted in the upper level of the structure.

The Singer Sewing Company occupied the Trost & Trost building from 1928 until 1980. The building contributes to the architectural diversity of downtown El Paso for it is a handsome example of the Mediterranean style. The ground floor was used for display and sales, while the second floor serviced a sewing school and a manufacturing trade department. The building was approved for listing on the National Register of Historic Places.

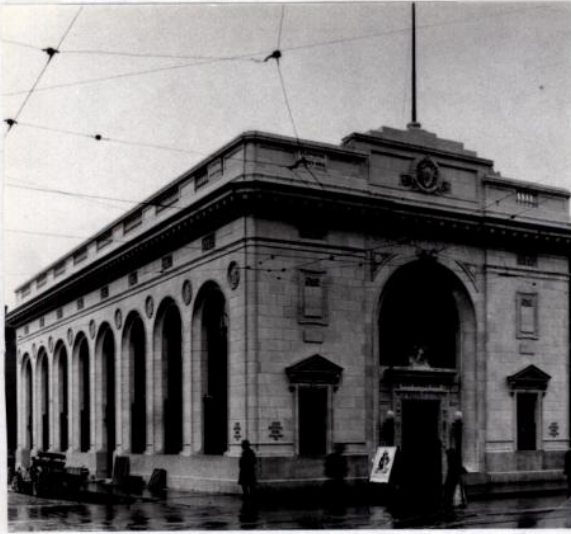
Founded in 1881, the State National Bank was an important financial base throughout the growth and development of El Paso. This was the second building for the bank, which was abandoned in 1971 when construction of the new facility was completed.

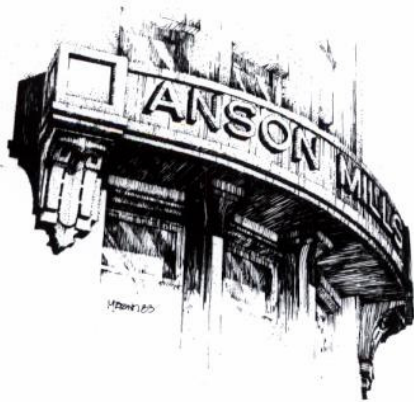
The Anson Mills Building

The Mills Building stands on the original site of the Jose Maria Ponce de Leon ranch. Construction of the building began in 1910 and was completed in 1911. General Anson Mills owned the property and had the building constructed for him according to his designs. General Mills was a prominent El Pasoan who was also the first surveyor to plat El Paso. Mills hired architects Henry and Gustavus Trost to help in the construction of the building. The Mills Building is significant for it was the first monolithic concrete building and the second reinforced concrete skyscraper in the nation.

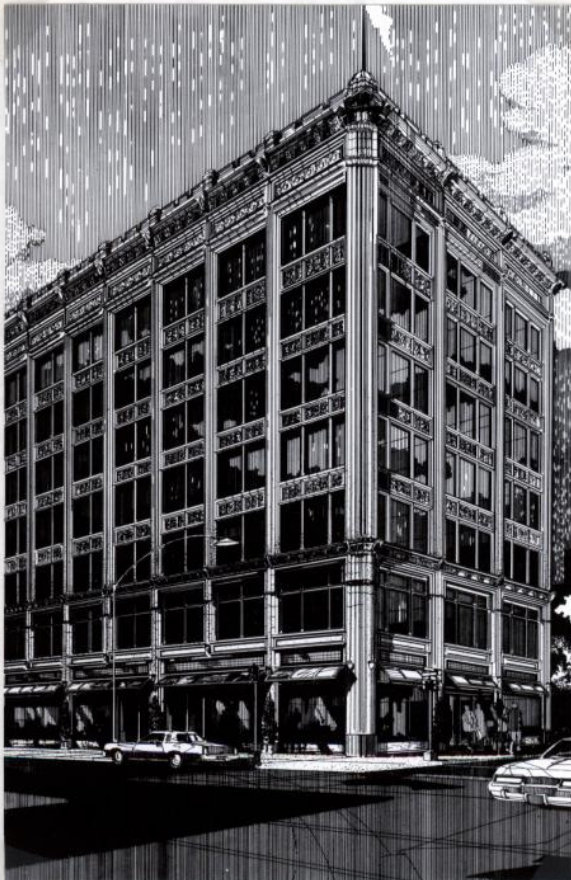
The Mills Building is a 12 story office tower in the shape of an "L", and stands at the corner of Mills and Oregon streets. There is a concrete balcony on the 11th floor and a wide overhanging cornice emphasizes the Chicago Style. The building has long vertical spans of windows that terminate in arches. "Anson Mills" is embossed in concrete on a balcony on the fifth floor.

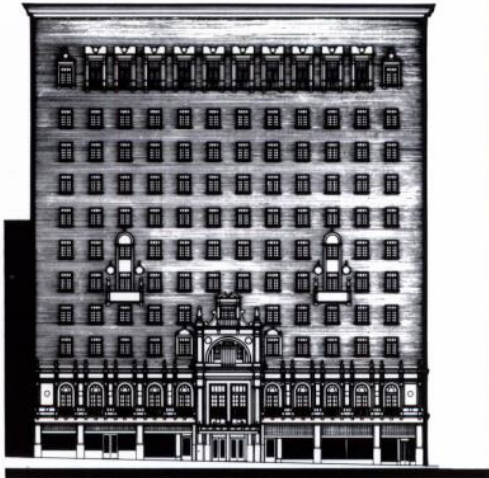
Hotel Cortez

The Cortez has twelve bays facing Mesa and ten bays facing Mills. A band of cast ornament encircles the outer walls of the second story. The entrance is emphasized by a "five-story cast relief portal, flanked by pairs of ornamented windows" on the sixth and seventh levels. The windows on the second and eleventh floors are emphasized through ornamentation. One of the building's distinct features is a series of portrait heads of conquistadors peering out of roundels above the Mesa Street entrance. The portrait heads are also part of the band of ornamentation of the second floor and surround the pairs of windows on the sixth.

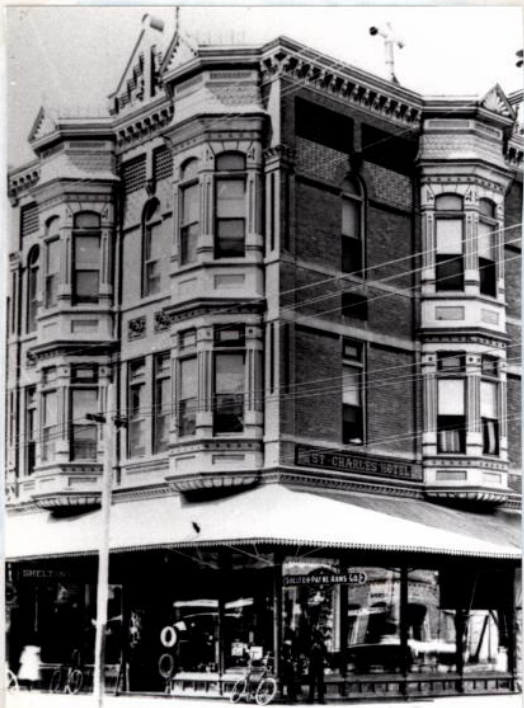
Merrick Building, St. Charles Hotel (Hollywood Cafe)

The Merrick Building was erected in 1887 by El Paso architects John J. Stewart and William J. Carpenter, for local businessman Charles Merrick. In 1931, it became the Hollywood Cafe and nightclub. The St. Charles Hotel, the oldest hotel in El Paso, has been located on the second and third floors of the building since 1890. The bottom floor of the building was traditionally used for retail purposes, and it originally housed a haberdashery.

The building originally had an 18-foot ceiling on the first floor supported by slender corinthian columns, but sometime after 1931 the ceiling was lowered to eleven feet. The columns remain, however, and could eventually be restored to view. The original storefront was of cast iron and had dogwood stained glass windows in the clerestory. The transoms above the windows were also originally or stained glass (some of which is still intact behind the aluminum siding that covers it).

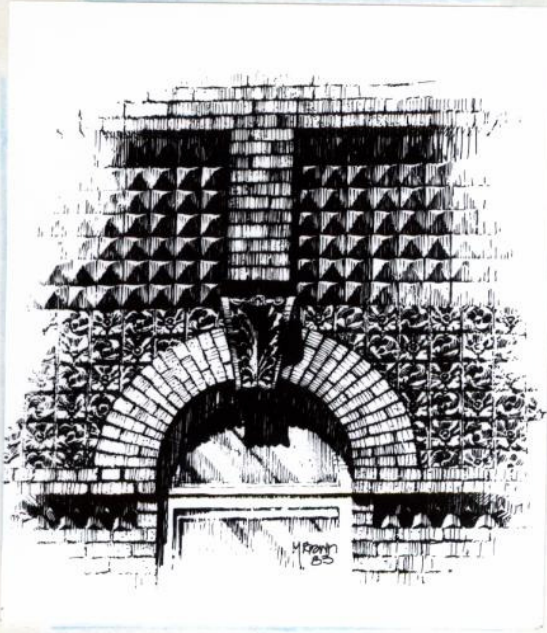
The building has a flat roof with a pediment on the north facade. The pediment is made of brick and has decorative terra-cotta work. A fine circular medallion sits atop the pediment. At the roof line there is an elaborate tin cornice with decorative dentils and medallions. Two projecting tin bays are located on the east and north facades. The windows are narrow double-hung sash, and the third-story windows have brick segmented arches. A concrete-over-brick banding lies above and below the bay windows. Above the central window on the eastern facade of the building there are projecting terra-cotta keystones. Above the storefront and along the northern facade is a cornice of tin simplified acanthus leaf.

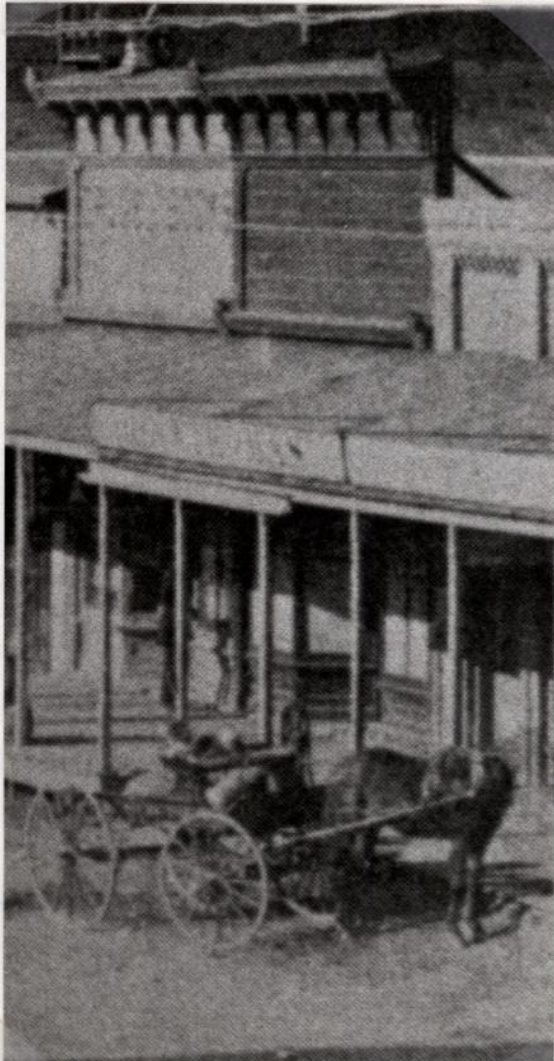
Dave's Loans is El Paso's last surviving false front structure. The building located at 216 and 218 South El Paso Street dates to approximately 1881-82. A sepia photograph taken in 1882 by F. Parker documents the structure.

The one-part commercial block is a simple box with a decorated facade. The type developed during the mid 19th century and most of these structures were used as retail stores. In many cases, the facade was simply comprised of display windows on either side of a recessed entry. A large wall area often existed between the windows and cornice. This area provided advertising space and made the building seem larger than what it actually was. This false front arrangement was especially common to small, wooden buildings that created the commercial core of new towns during their initial development.

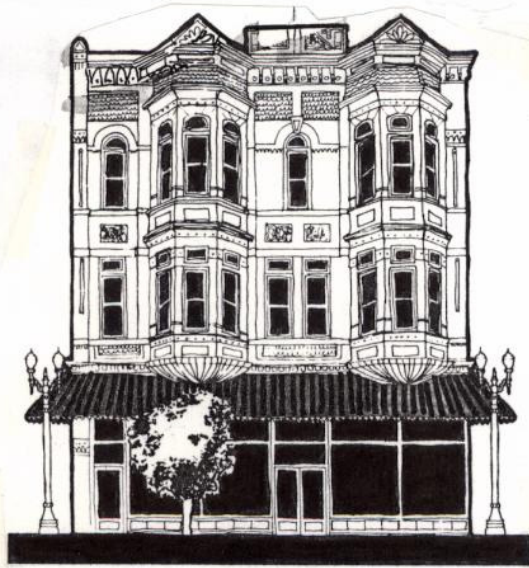
The one-part commercial block is essentially a single story structure with a recessed entry and a decorated facade. Two-part commercial differs from one-part in height only. The two-part commercial block is simply a structure of two to three stories and is characterized by a horizontal division into two distinct zones. Although the overall building was constructed in a particular architectural style, zones may or may not be similar. For example, lower zones (street level) have been altered to the extent that it is no longer in character with the upper zones.

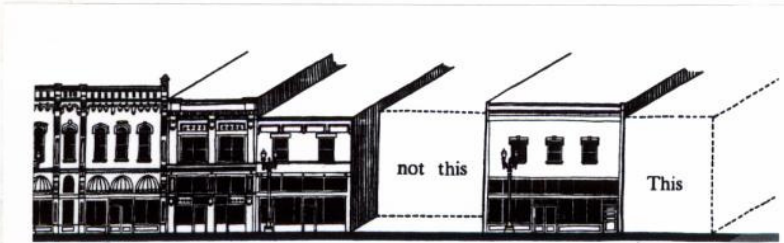
- Setbacks are not present in the historic district; in general all new construction should abutt the property line if it is in keeping with the surroundings.
- Setbacks are permissible, however, if they occur after the first two stories. (The Plaza Hotel illustrates this concept.)
- New development shall comply with the requirements for the underlying residential, apartment, or commercial zone.

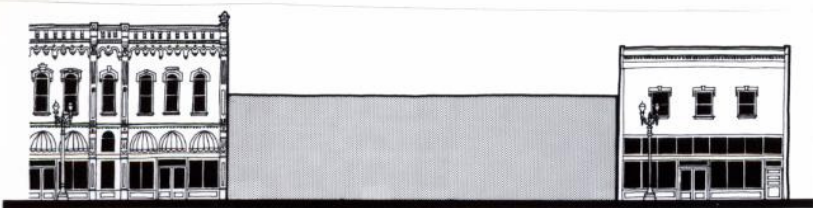
NO

- Pioneer Plaza Zone: Proportion and spacing of new construction should be similar to that of the Mill's Building or the Plaza Hotel.
- San Jacinto Plaza Zone: Proportion and spacing of new construction should be similar to those existing buildings facing the plaza: Mill's Building, Banner Building and the Cortez.
- San Antonio Zone: Proportion and spacing of new construction should be similar to that of the one or two-part commercial type.

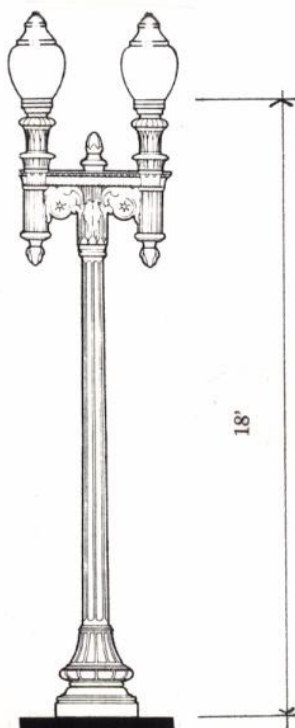
Lighting should consider all of the previously mentioned purposes. The following guidelines apply to all zones.

- Contemporary lighting fixtures should be replaced with period lights found in Pioneer Plaza.
- Lighting should be provided in alleys and parking areas/lots.

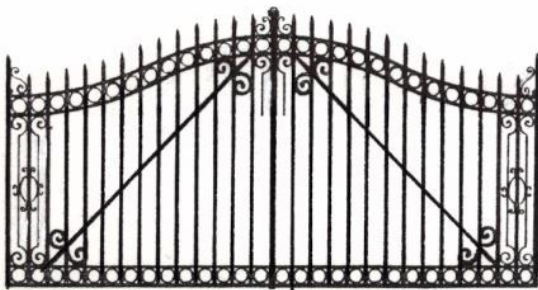
- Generally, fencing should be of brick and/or wrought iron.
- Chain link fencing is not historic and is considered inappropriate.

- Solid fencing on commercial properties located on any corner lot, shall not exceed three (3) feet in height. (Chapter 12.68 city ordinance, visibility obstructions.)

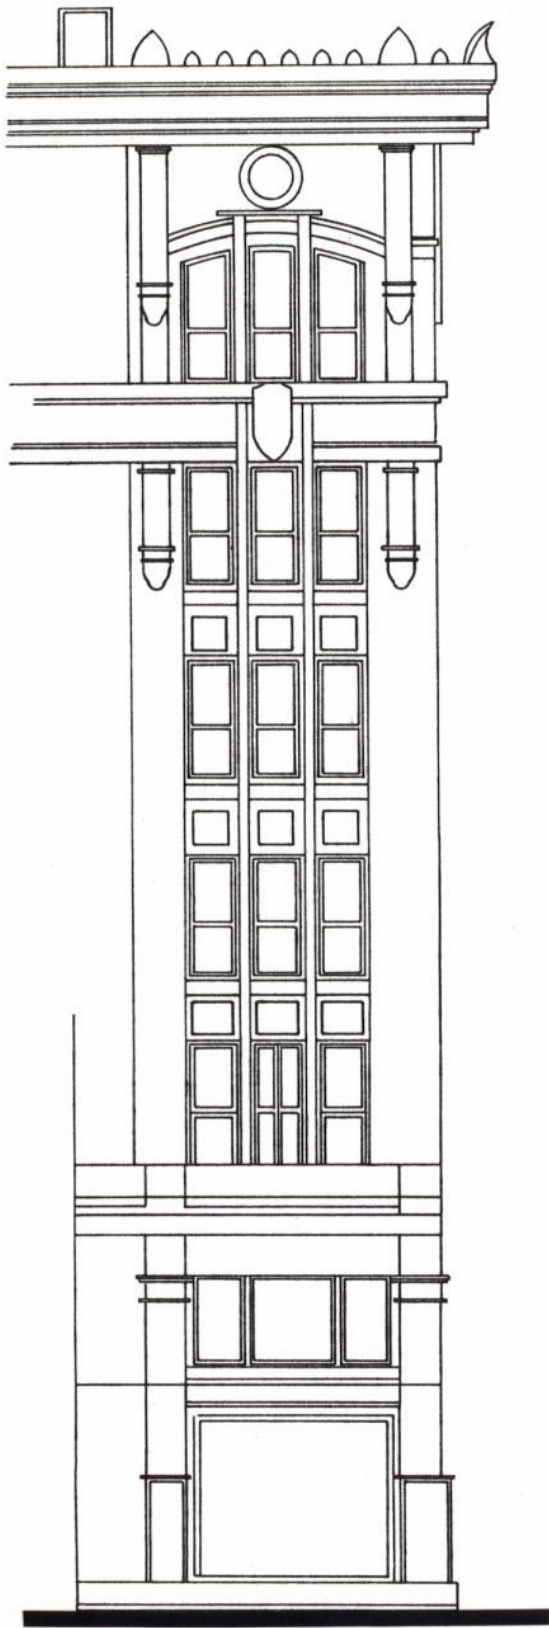
- Replacement windows should match the same size of the original. In other words, new windows should fill the entire space. The practice of "blocking up" and/or "blocking down" existing window openings to fit a smaller standard sized window should be avoided.

- Painting over windows, blocking in and/or boarding up windows drastically alters a building's character and may result in the loss of its architectural integrity.

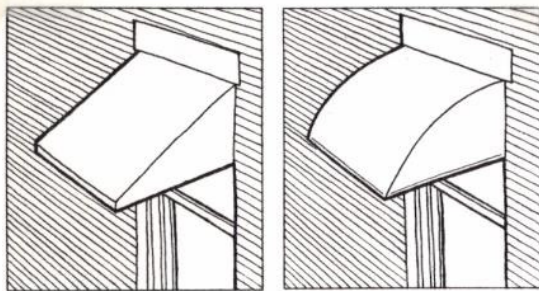
Standard

Convex

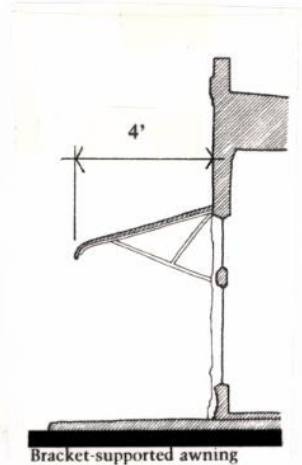
- Awnings should not cover more than one-third of the window opening. Unproportioned awnings may appear awkward.
- Fixtures should always fit within their openings. Attempting to fit a square awning into a round opening (and vice-versa) should be avoided. Generally, the shape of an awning should respect the shape of the window.
- Colors on awnings and canopies should be considered carefully. Generally, colors should relate to a structure's overall color scheme.
- Adjacent awnings should not fight each other for attention by using bright colors that might overwhelm a structure and/or an entire streetscape.
- Graphics on fabric awnings should be placed on the slope or valence. On canopies, signs can be mounted above (along its front edge), or shingle signs can be suspended from the ceiling.

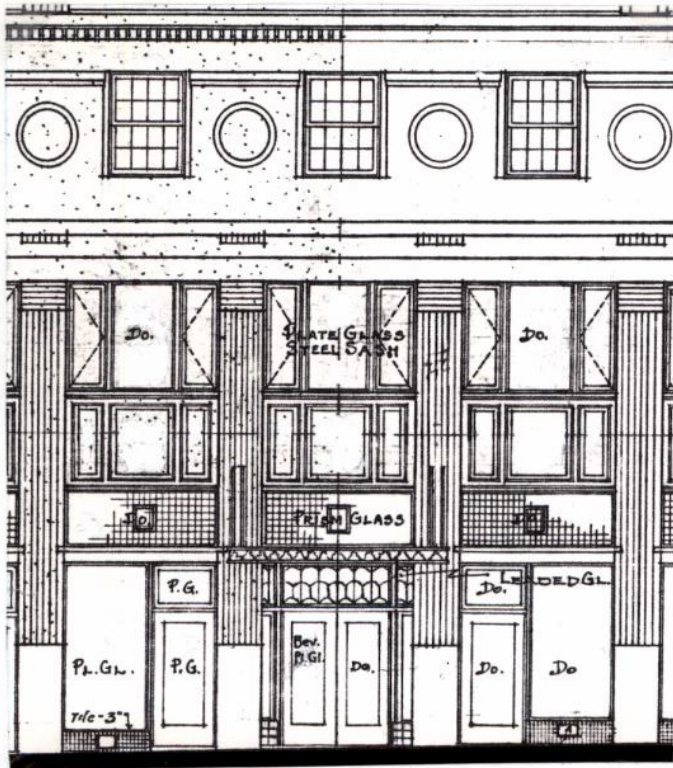
- Pioneer Plaza Zone: It is recommended that storefronts be similar to that of the Mills or Center buildings: large display windows, a small wainscot at the bottom and a recessed entry.
- San Jacinto Plaza Zone: It is recommended that storefronts be similar to that of the Cortez. The storefront has a relatively small wainscot with large display windows and the large double entry doors are topped with a transom.

- San Antonio Zone: It is recommended that storefronts reflect the recessed entry typical of the one and two-part commercial type.
- South El Paso Street Zone: It is recommended that storefronts reflect the recessed entry typical of the one and two-part commercial type.

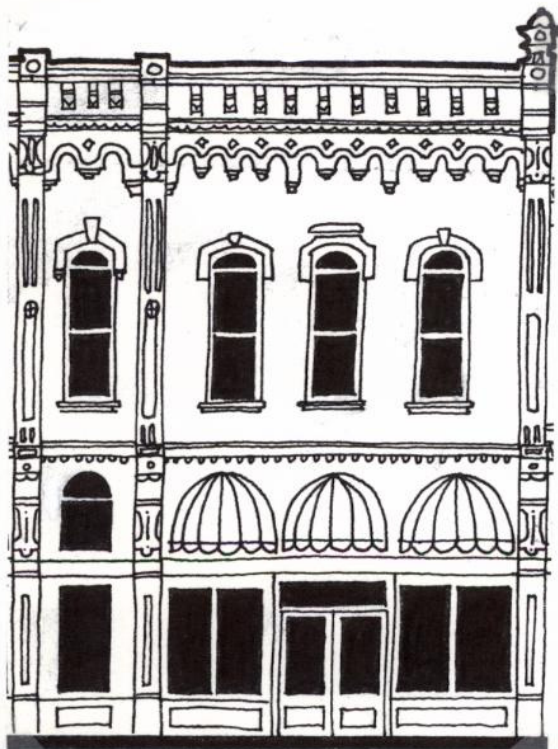
- The original size, division and shape of display windows should be retained. Glass should be transparent for pedestrian viewing.
- Bars or offices in storefronts should use blinds or cafe curtains for privacy.
- The wainscot or panel beneath the display window should be constructed of wood or brick. Plastic and metal sidings are not historic and should be avoided.
- Transom windows should be preserved and/or restored where possible. Transom windows may still be found underneath dropped ceilings and exterior coverups.*

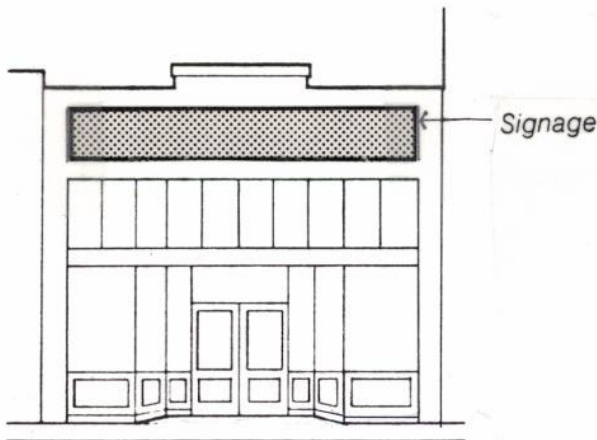
- Banners are prohibited, with the exception that they may be used for a period not exceeding 10 days for grand openings and charitable functions only.
- Signage should be limited to the drop flaps of the awning.
- Awnings made of fabric are more appropriate to the downtown and the South El Paso Street area, and colors should coordinate and complement the building, adjacent buildings, and the general vicinity.

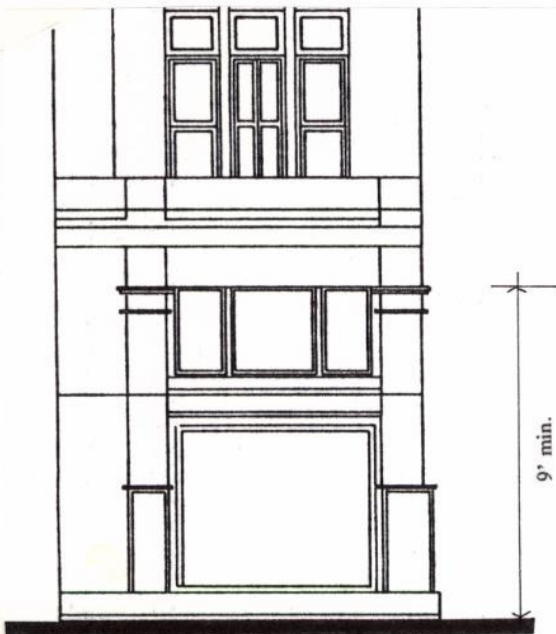
- Double-faced projecting wall signs must have a minimum nine foot clearance between the bottom of the sign and the ground level.
- Projecting signs are prohibited at the intersection of building corners, with the exception if they are at right angles to a building front.
